## Gooch Hill Road Corridor

### INTRODUCTION

Both the *Greater Transportation Area Transportation Plan (GTATP)* and *Safe Streets and Roads for All (SS4A) Action Plan* identified several smaller, targeted improvements to address issues such as run-off-the-road crashes on curves and conflicts at unconventional intersections. In the GTATP, curve signing enhancements at Enders Road and Gant Road are recommended along with intersection improvements at Blackwood Road, and reconstruction to urban standards between Huffine Lane and Stucky Road. The SS4A plan perpetuates the curve signing recommendations at Enders Road and Gant Road, and proposes additional intersection improvements at Stucky Road, Chapman Road, US 191, and Huffine Lane.

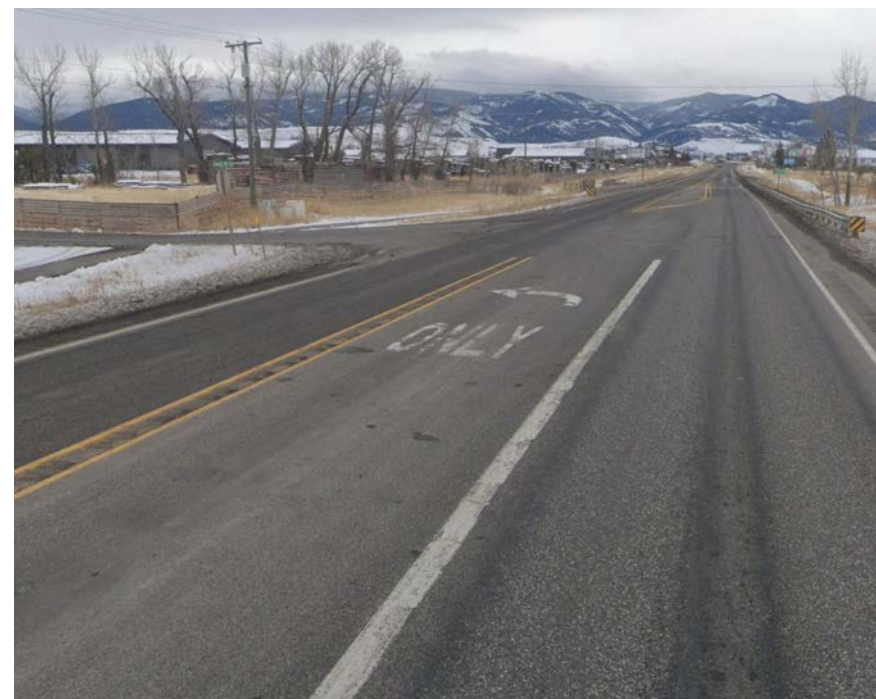
Given the combination of operational and safety issues, this intersection requires further evaluation to identify an appropriate improvement strategy. Options that may warrant consideration include a traffic signal, roundabout, or continuous T-intersection design. Each alternative carries distinct benefits and challenges related to safety, efficiency, and cost. A full intersection study should be conducted to determine the most effective long-term solution, particularly given the presence of a bridge just south of Gooch Hill Road that may constrain future design options.

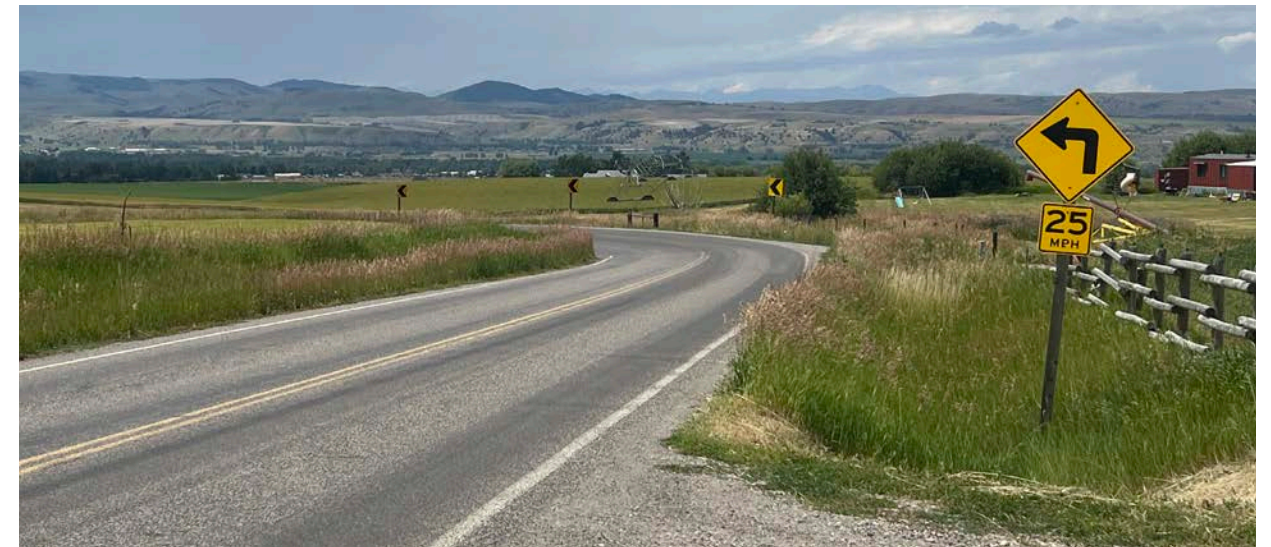
The segment of Gooch Hill Road between Law Road and Enders Road presents several geometric and roadside challenges. The existing curves in this section do not meet current design standards for a 50-mph roadway, raising concerns about long-term safety and consistency with driver expectations. While speed data shows that most motorists travel at or below the posted speed limit, a reduced speed zone of 35 to 40 mph could be helpful to better align operating speeds with roadway geometry and improve driver expectation and safety. However, a formal speed study should be conducted to confirm an appropriate speed.

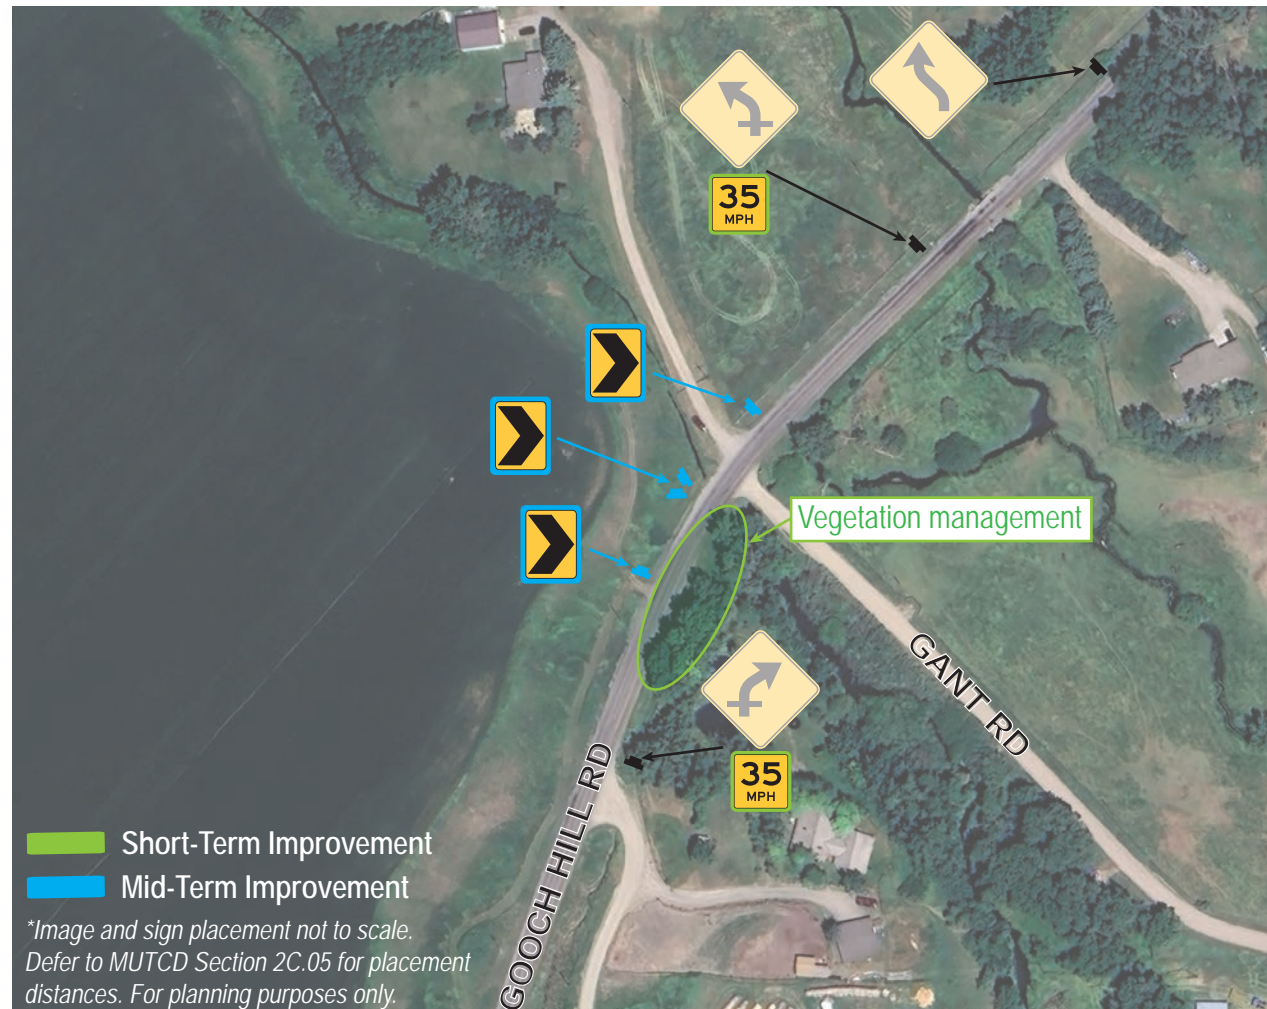
The Gant Road intersection was also identified as a high-priority curve in the Run-off-the-Road Supplemental Planning area. The intersection itself is located on a curve along Gooch Hill Road, creating additional safety concerns. Mature vegetation along the southeast edge of the roadway obstructs sightlines to Gant Road, the approaching curve, and oncoming traffic from both directions, limiting driver visibility and reaction time.

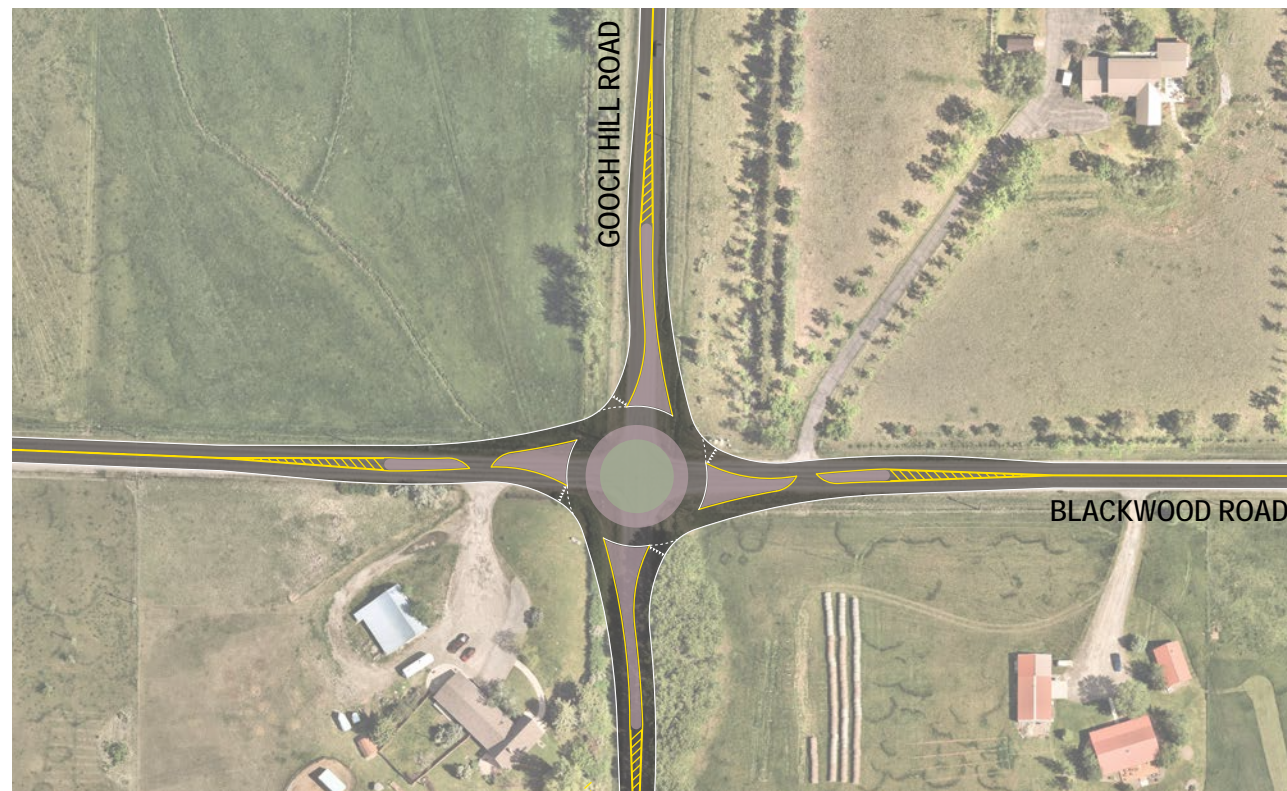
The Blackwood Road intersection has experienced a notable crash history, with 10 crashes reported during the analysis period, and 90 percent of which were right-angle collisions. The intersection is currently configured as a four-leg intersection, with stop control on the east and west legs of Blackwood Road. The stop signs on Blackwood Road have small flashing red beacons and toward the end of the crash analysis period in 2022, "Cross Traffic Does Not Stop" placards were also added. From an operational standpoint, the intersection currently functions at LOS B during both AM and PM peak hours. However, by 2045, conditions are projected to degrade to LOS D during both peak periods as traffic volumes increase. Importantly, traffic volumes at this location do not currently meet signal warrants, making near-term signalization an unlikely solution.

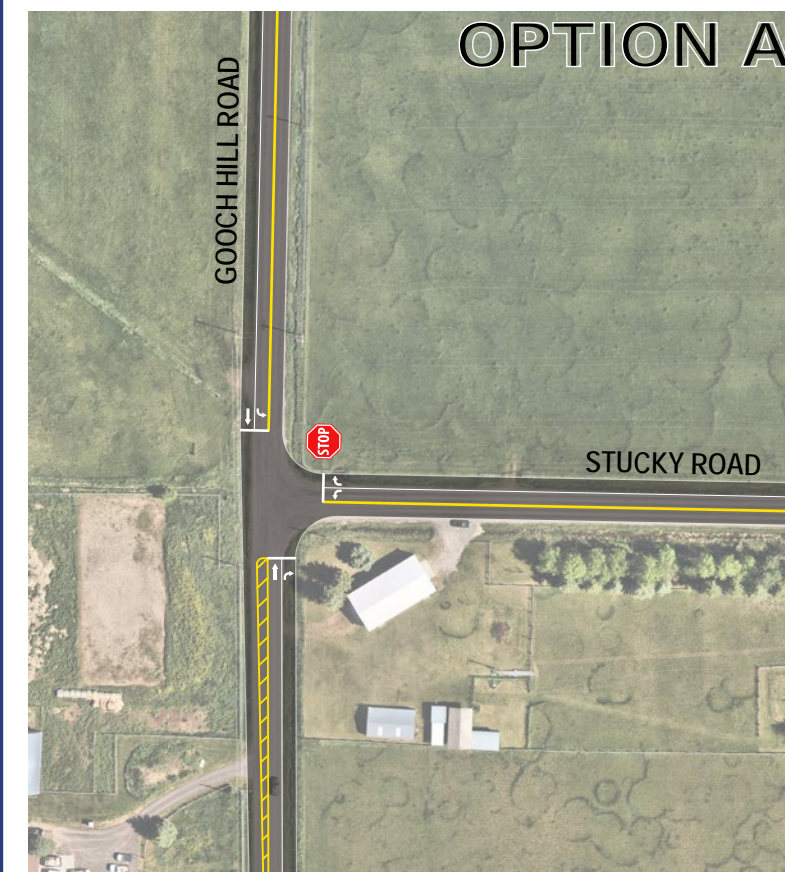
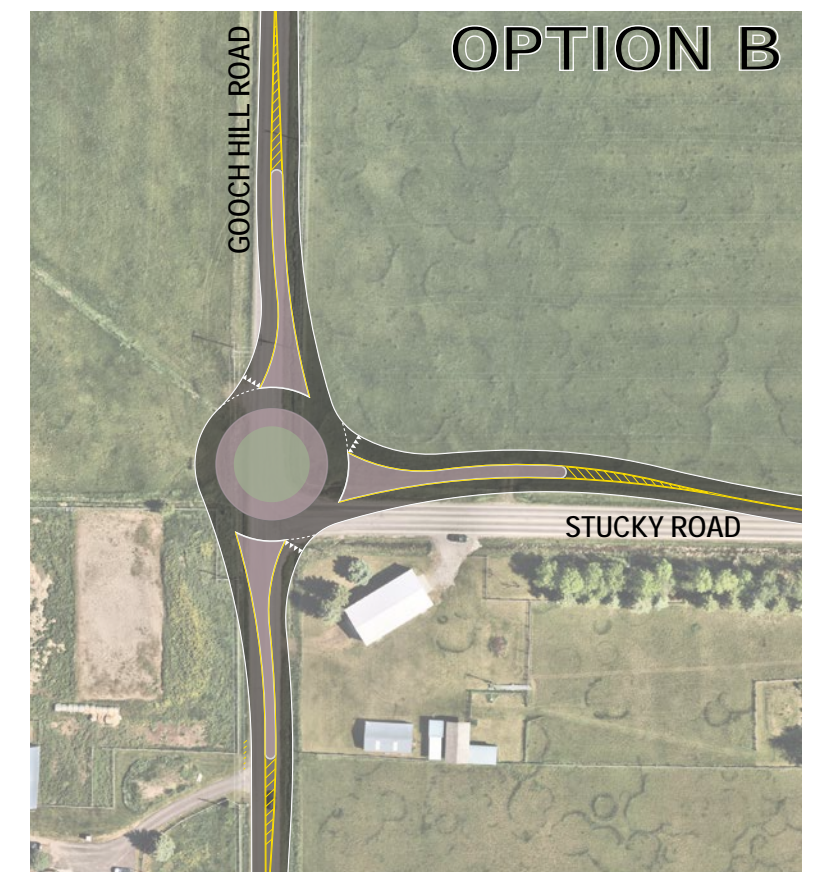
The GTATP recommends extending Stucky Road east to connect with Elk Lane/Red Mountain Drive (MSN-16), thereby creating a four-legged intersection. In the long term, geometric and traffic control improvements will be necessary to address both operational and safety issues. A roundabout would improve safety and restore operations to LOS A under 2045 traffic conditions while easily accommodating a fourth leg in the future. The addition of turn lanes to the current two-way stop configuration would provide only marginal benefit, with operations still projected at LOS E. Signalization in combination with added turn lanes could achieve LOS B, however, traffic volumes at this location do not currently meet signal warrants.

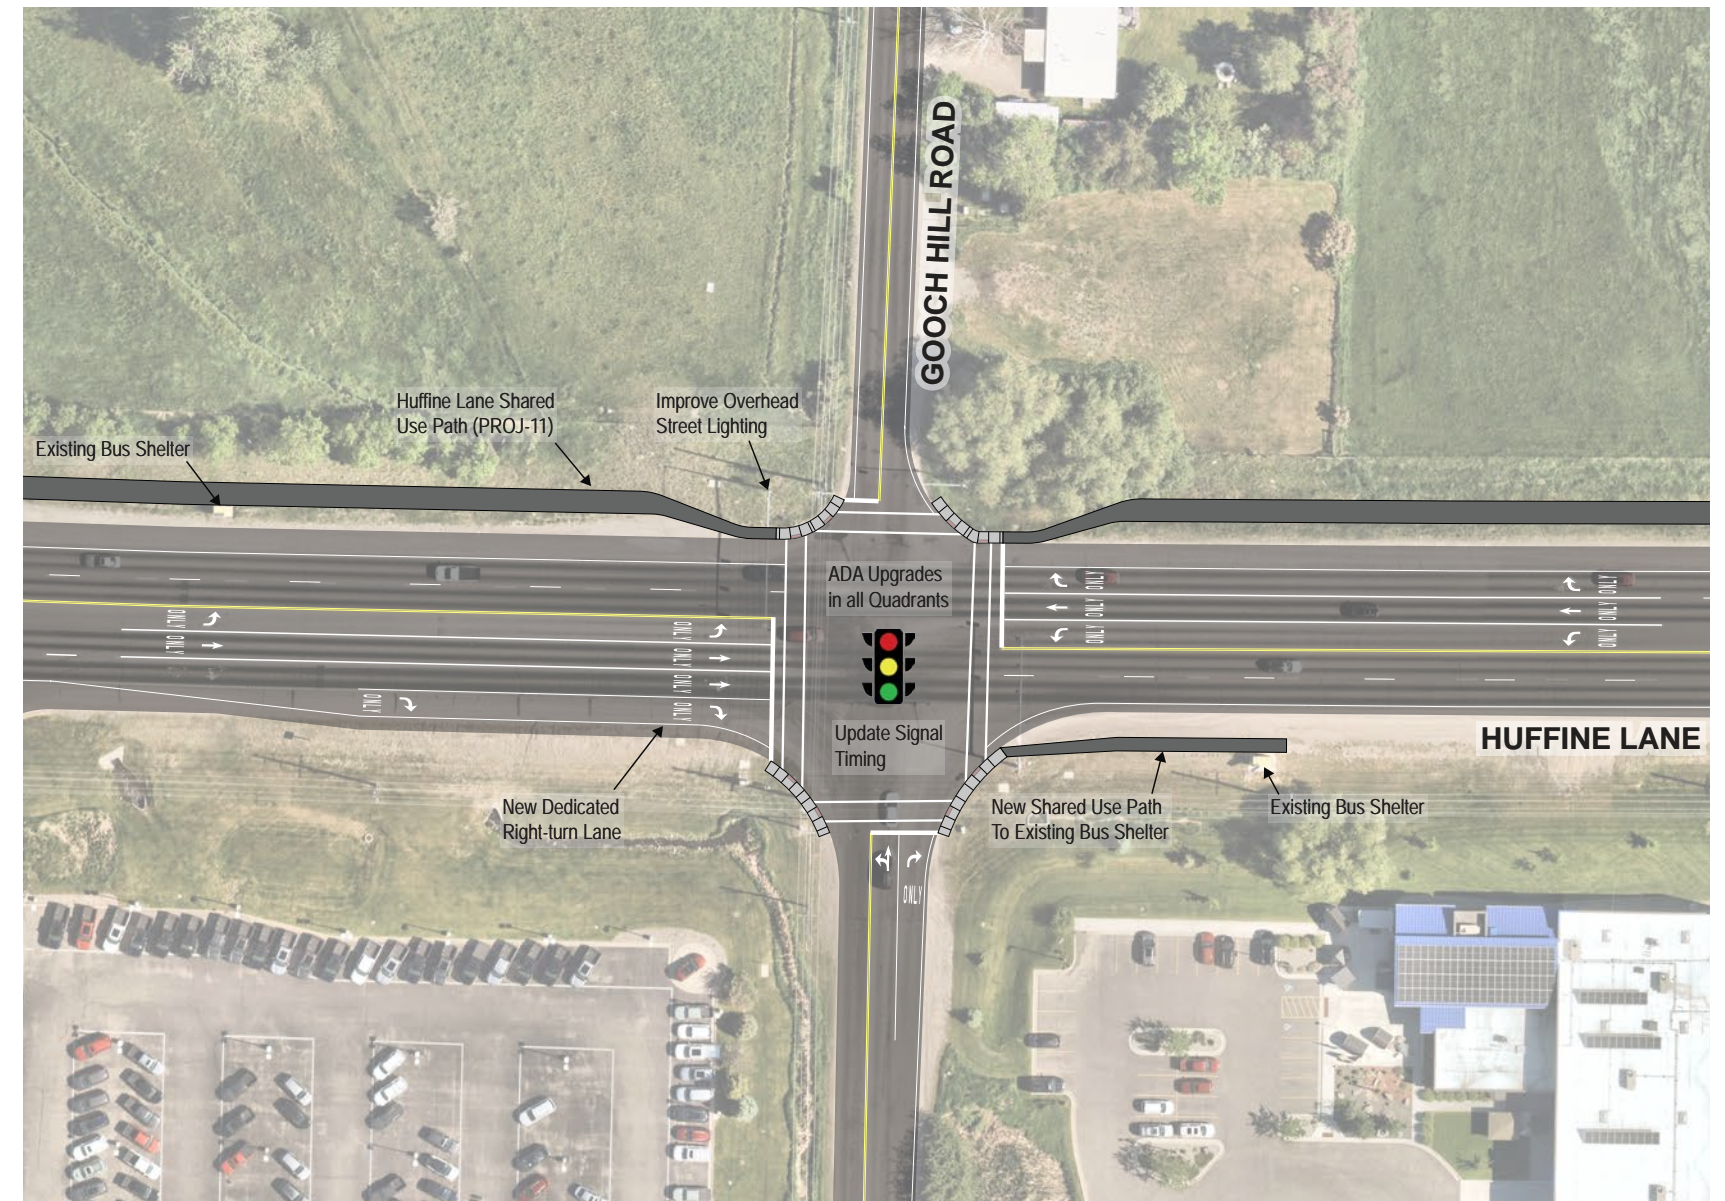
Reconstruction of this high-crash intersection is aimed at addressing recurring safety issues, including rear-end collisions, nighttime visibility, and red-light running. Proposed improvements include intersection lighting, construction of an eastbound right-turn lane, and signal timing upgrades to improve operations and reduce conflict points. The project also incorporates ADA-compliant facilities, including an accessible path in the southeast quadrant to connect with a nearby transit stop, along with ADA-compliant corners at all approaches. These upgrades will also link to a planned shared-use path on the north side of the intersection, further enhancing multimodal accessibility.
